**CONNECTICUT RIVER BASIN
BETHLEHEM NEW HAMPSHIRE**

**BETHLEHEM DAM
N.H.00279**

**PHASE I INSPECTION REPORT
NATIONAL DAM INSPECTION PROGRAM**

APRIL, 1979

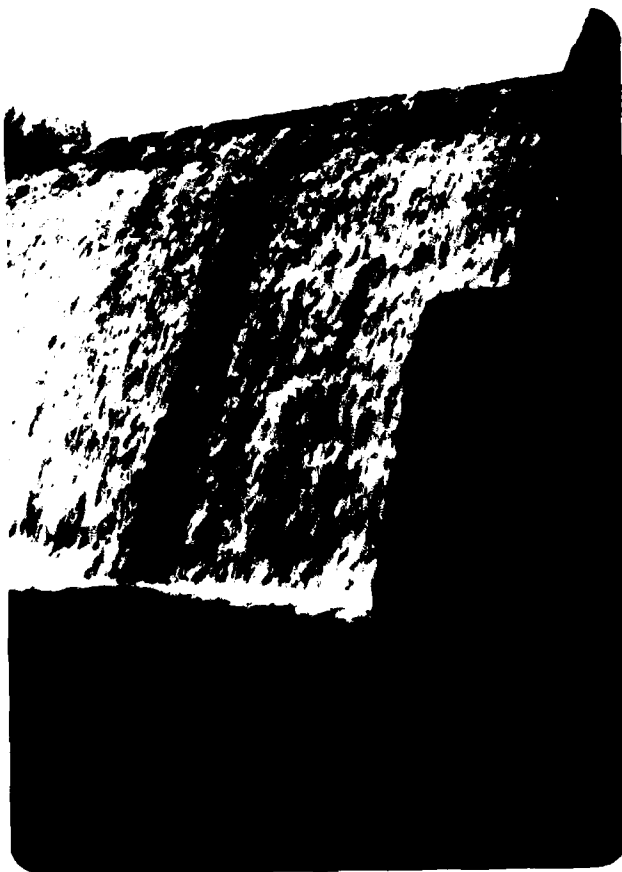
The concrete spillway was found to be in generally good condition based on a limited visual inspection. The downstream face of the spillway shows some signs of erosion, especially at the construction joints between the compartment sections (see Photos 2 and 11).

#2. VIEW OF LEFT
SIDE SPILLWAY
SHOWING ERODED
JOINT

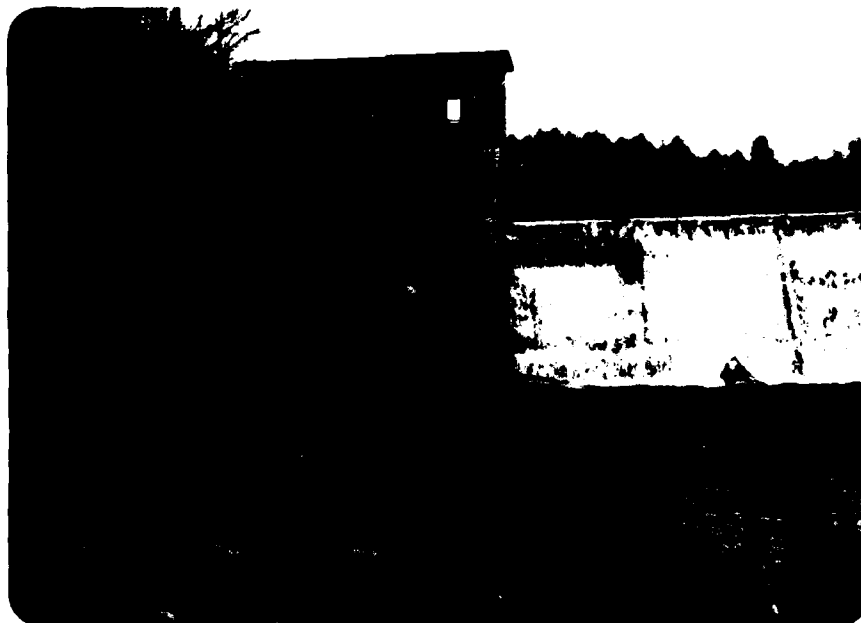
A dark area can be seen on the downstream face of the first compartment from the right just below the crest (see Photo 5). This area indicates a smoother surface and may be a repair patch applied in the past. Anchor bolts and plates found in the interior of the first compartment support this assumption.

#5. VIEW OF GATE WORKS AND RIGHT SIDE
SPILLWAY

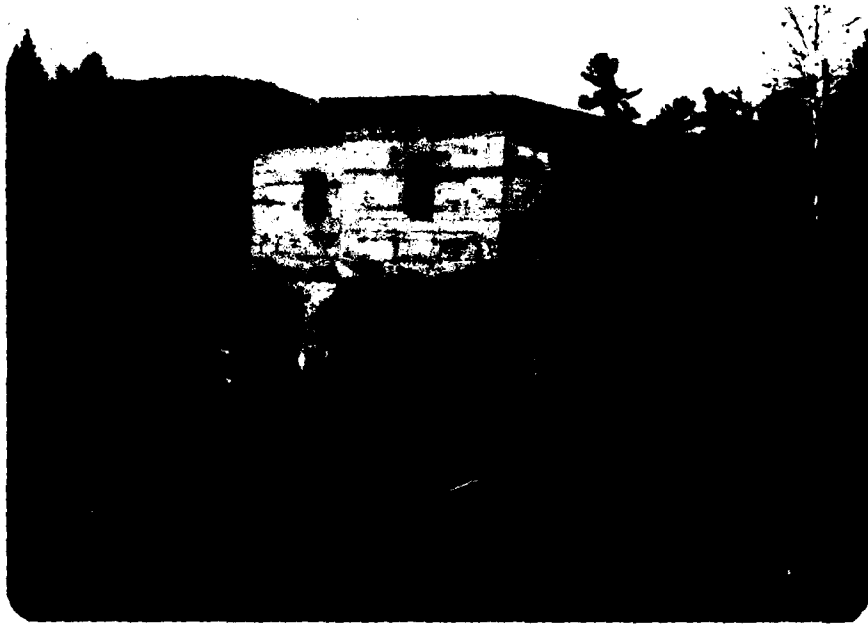
The right side core wall extends from the gate works into the right river bank. The wall is exposed for approximately 20 feet adjacent to the gate works. Earth embankment material has eroded and the core wall is spalling (see Photo 7).

#7. UPSTREAM VIEW OF GATE WORKS AND CORE WALL

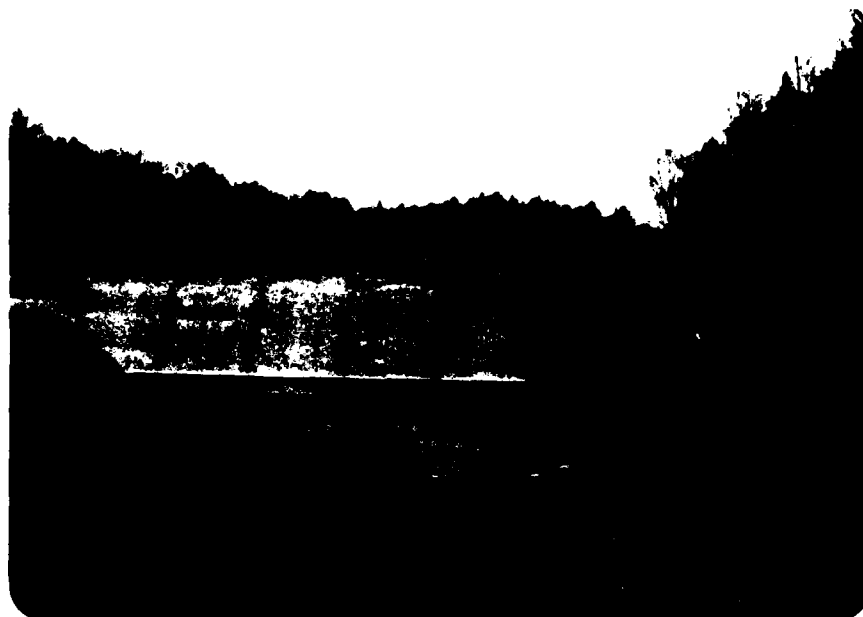
Photo 9 shows a typical section of the downstream channel which is the natural river bed of the Ammonoosuc River. The river bends to the left just downstream of the dam and narrows considerably. Ice jamming occurs during the spring runoff in this area. Damage to trees on both banks indicates that the ice jamming is very extensive and often approaches the height of the dam.

#11. VIEW OF DOWNSTREAM CHANNEL
